Reestablishing vegetation on interventions along rivers

A compilation of methods and experiences from the Tana River valley

Report no 29

Published by: Norwegian Water Resources and Energy Directorate

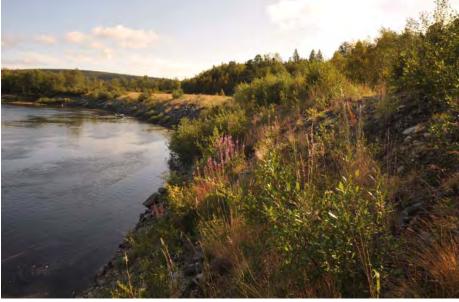
Figure 1.1 Former sterile erosion control construction at Jeabmelisnjarg has now almost complete cover of riparian vegetation and the slopes are completely stabilized. Photo: Gunnar Kristiansen, NVE

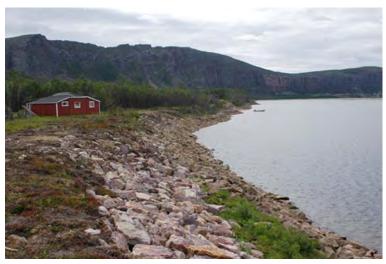
Figure 3.1.2 Erosion control construction in the outlet of the Tana River. Photo: Knut Aune Hoseth, NVE

The most common method for constructing erosion controls, and the method applied along Tana, is to cover the erosion prone riversides with rocks, see figure 3.1.1 and 3.1.2 below. While rocks offer some resistance against mass movement, the primary purpose is to prevent loss of bank material by fluvial erosion, to increase the stability and prevent the river to dig and erode. Solid stone material is less erodible, making the slopes less prone to erosion and so protecting adjacent land, farmland, roads and buildings. Erosion controls constructed of rocks are in general highly durable and suitable to protect against erosion caused by both water, wind and ice (Fergus & Hoseth et.al.2010).

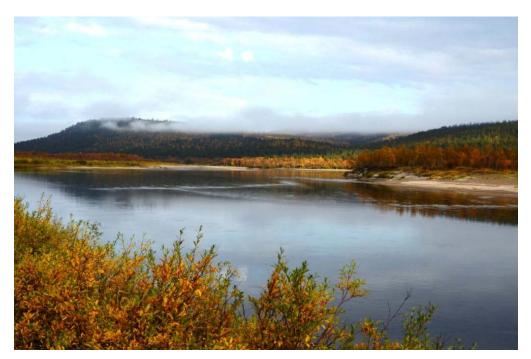
Figure 4.1 Section of the Tana River showing natural riparian vegetation and the variation in substrate with parts of open sand and silt, rocks and vegetation growing almost down in the river. Photo: Gunnar Kristiansen, NVE

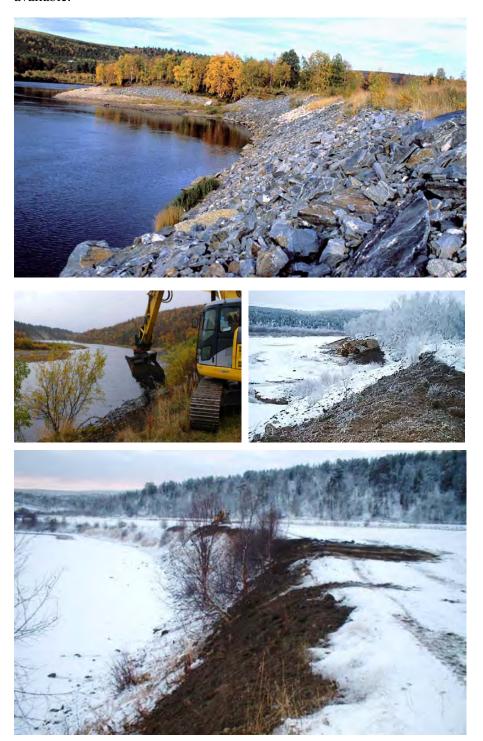
Figure 7.1 Erosion control constructions with coarse rocks, resulting in sterile and harsh environmental conditions (above). Excavator moving soil over the slope, covering the rocks with growth masses and improves the conditions for plant growth (below). Photo: Gunnar Kristiansen, NVE

The soil should be moved over the erosion control construction in early autumn or winter, this way, the spring flood is avoided and the growth masses have time to "settle" during autumn and winter. The soil can be used in its natural condition or mixed with sand. It is possible to use sand from the river bottom as substrate. However, close consideration is needed to not harm valuable areas for fish and other life in the river. In many cases the erosion control constructions have been constructed very steep, which further hampers the conditions for re-establishing vegetation. In these cases, it is essential to reduce the inclination of the slope prior to further measures. This can be done by shaving/cutting of the upper part of the erosion control constructions, and move the excess masses downwards and add a substantial amount of soil and fine material to gentle down the slope.

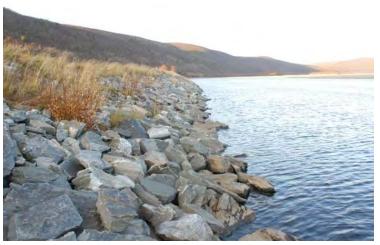
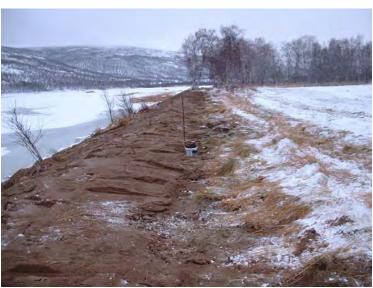
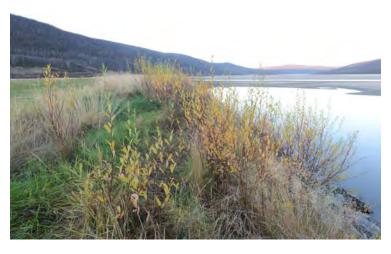
Figure 7.2 Sterile erosion control construction of coarse stone material. The same section after sand from the river bottom have been added., and vegetation mats moved from the toparea to the stone area. Eight years after the measure a complete cover of vegetation is established Photo: Gunnar Kristiansen, NVE

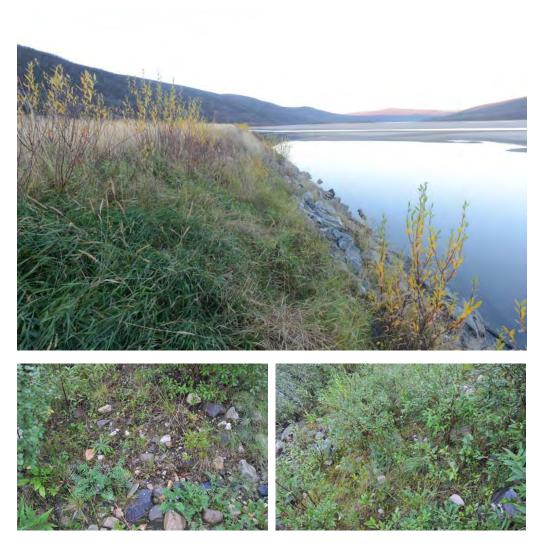
Figure 8.1 Meadow species are dominating the composition of the vegetation at Valjok. This example illustrate how grass species can dominate the plant community in the riparian zone if sowed with no considerations for the local vegetation. Pictures below illustrate a natural mosaic of vegetation with great diversity in both species and layers of grass, herbs, and bushes. Photo: Gunnar Kristiansen, NVE

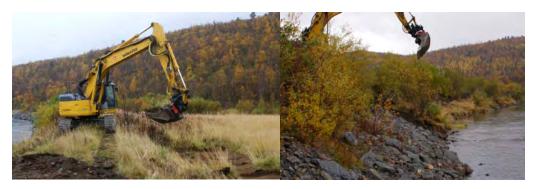
Figure 9.1 Excavator moving large and smaller vegetation mats with soil and growth substrate, completely covering the slope. Photo: Gunnar Kristiansen, NVE

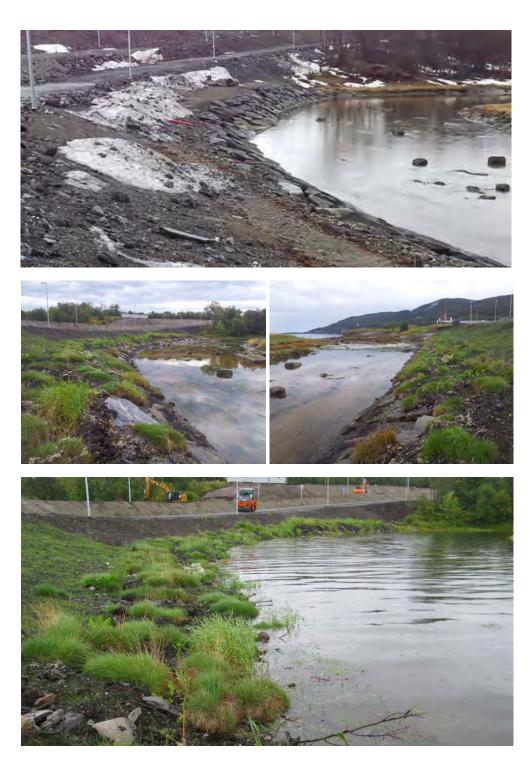
Figure 9.4 Moved turfs of sea shore vegetation in the transition between the outlet of Storelva and the tidal zone. The turfs was temporarily stored at the plant for approximately two years, the pictures show the site only weeks after they were placed out in 2013. Photo: Statens Vegvesen/v Elisabet Kongsbakk

(engrapp), *Agrostis capillaris* (engkvein) and *Hieracium*. (svever sp) Some small mats and turfs with heather, blueberries and lingonberries has started to grow. An even layer of mosses has also established. See fig.9.4.

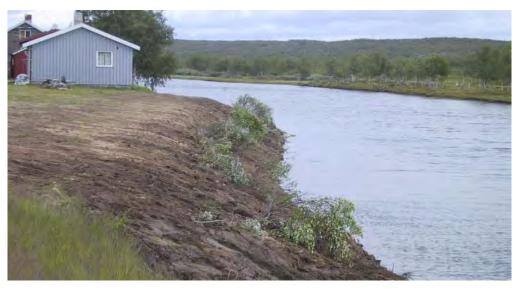
Figure 10.1 Clusters of trees and bushes mooved and planted on erosion control construction at Mollisjok along Karasjohka. Photo: Gunnar Pedersen, NVE

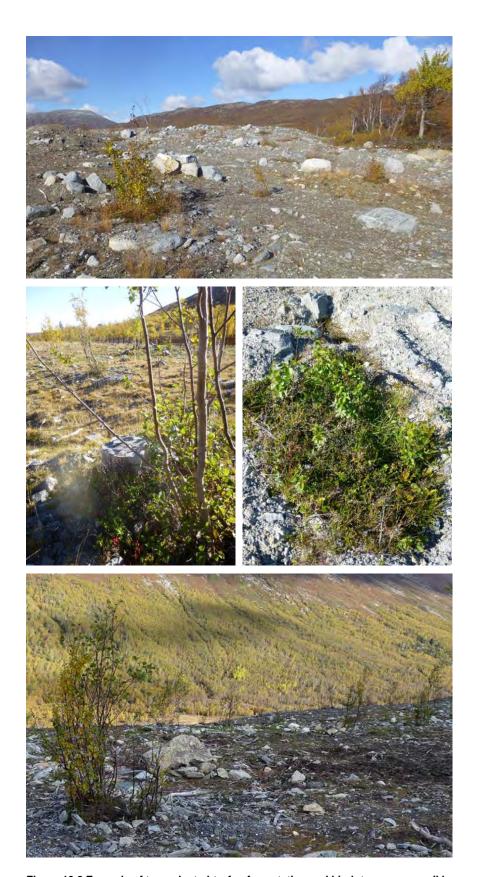
Figure 10.2 Example of transplanted turfs of vegetation and birch trees on a spoil heap covered with moraine in alpine areas in south in Norway. Photo: Arne Hamarsland, NVE

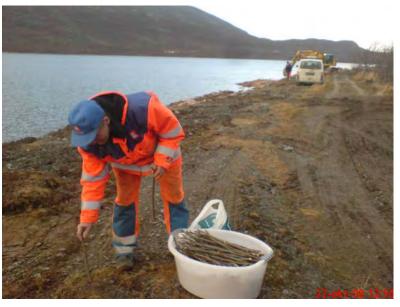
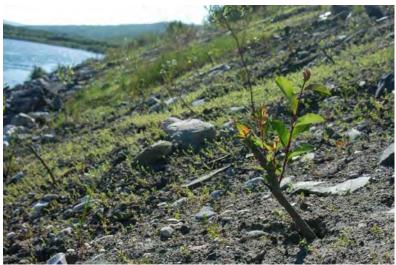
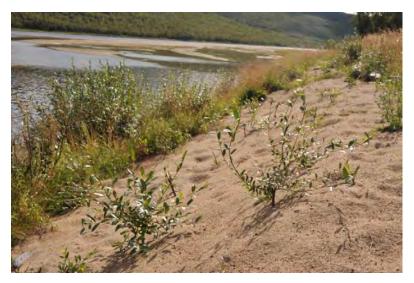
Figure 11.1 Planting cuttings directly after preparation. The cuttings are being propagated naturally in the ground and new branches are sprouting resulting in small bushes of willow, and in time forms a bush layer on the riverbank. Photo: Gunnar Kristiansen, NVE

Cuttings of Salix grow well in sandy mineral substrate like illustrated in figure 11.1. The cuttings can also be planted in coarse stony substrate if there is some finer substrate in between the stones for the cuttings to attach to. If the cuttings are not washed away by the first flood; they grow well in the coarse material. See figure 11.2.

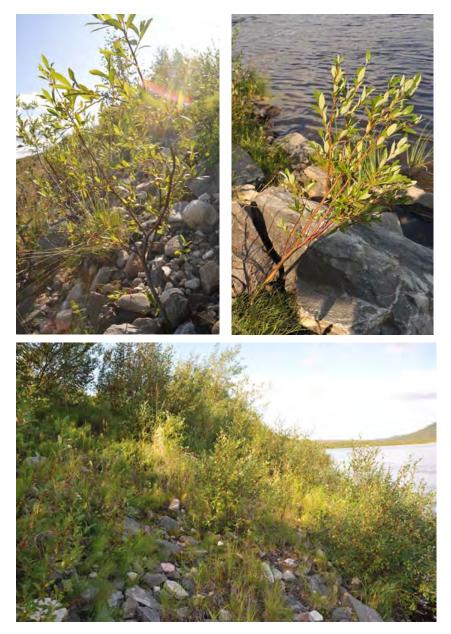
Figure 11.2 Stem cuttings of willow grown into a viable tree in the coarse substrate creating a functional bush layer in the riparian zone Photo: Gunnar Kristiansen, NVE

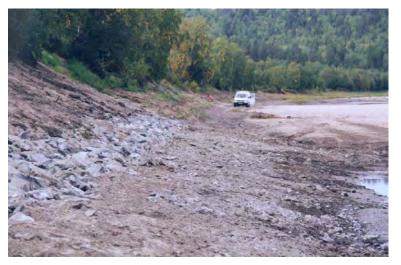
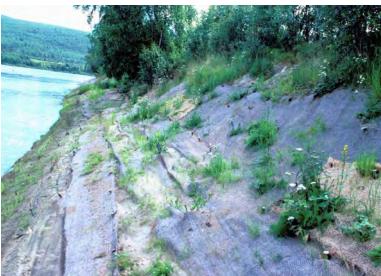
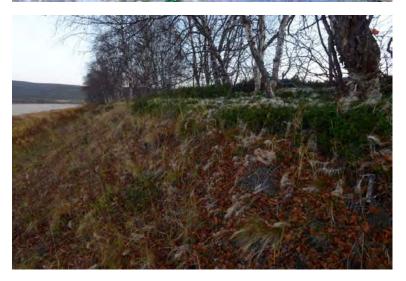
Figure 12.1 Prepared slope at Hoassinjarga before installing the coir nets. The growth substrate consists of a mix of soil, organic material, silt and rocks. After a period of time vegetation is starting to establish. After 15 years the coir nets is partly and completely decomposed. The slope is stabilized and complete cover of vegetation has been established. Erosion of the slope has fully ceased. Photo: Gunnar Kristiansen, NVE

Biodegradable geo-textiles made of coconut coir fiber was used at Hoassinjarga along the Tana River, mainly as an erosion measure to stabilize the bank and promote plant growth. The geo-textile used need to be durable because it is likely to be the primary stabilizing medium for some time before being supplemented by vegetation growth. The coir nets at this site was in some sections almost completely decomposed after approximately 15 years, in other sections partly decomposed and still visible but with estimated ninety to hundred percent vegetation cover.

In the lower section of the site the coir nets are almost completely decomposed while in the higher and steeper sections the mats are still visible but are about to disintegrate. Mechanical stress from ice drift has most likely been dominating at this site. In total, the use of coir nets have been successful, erosion have completely ceased, and there have been established almost complete plant cover.

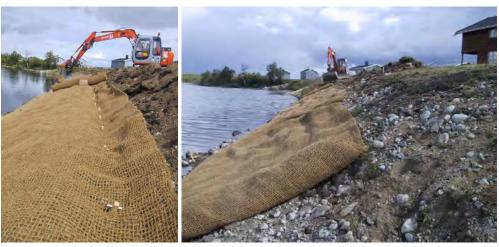
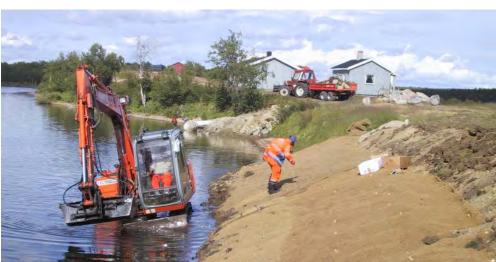
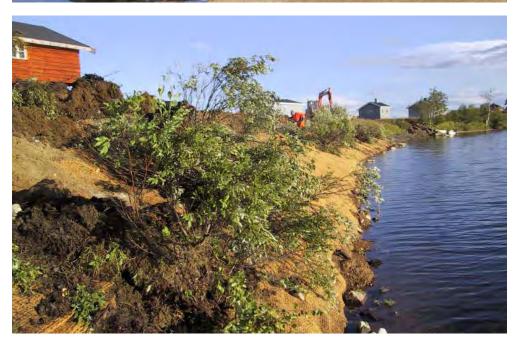
Figure 12.3 Erosion prone slope at Mollisjok along the tributary river Karasjohka, secured with geotextiles from further erosion of the slope. At this site soil and turfs of plants and bushes was moved over the slope immediately after applying the geotextile. Photo: Gunnar Pedersen, NVE
